# *Report to the President*

## **PRESIDENTIAL COMMISSION**

*on the Space Shuttle  
Challenger Accident*

June 6th, 1986  
Washington, D.C.

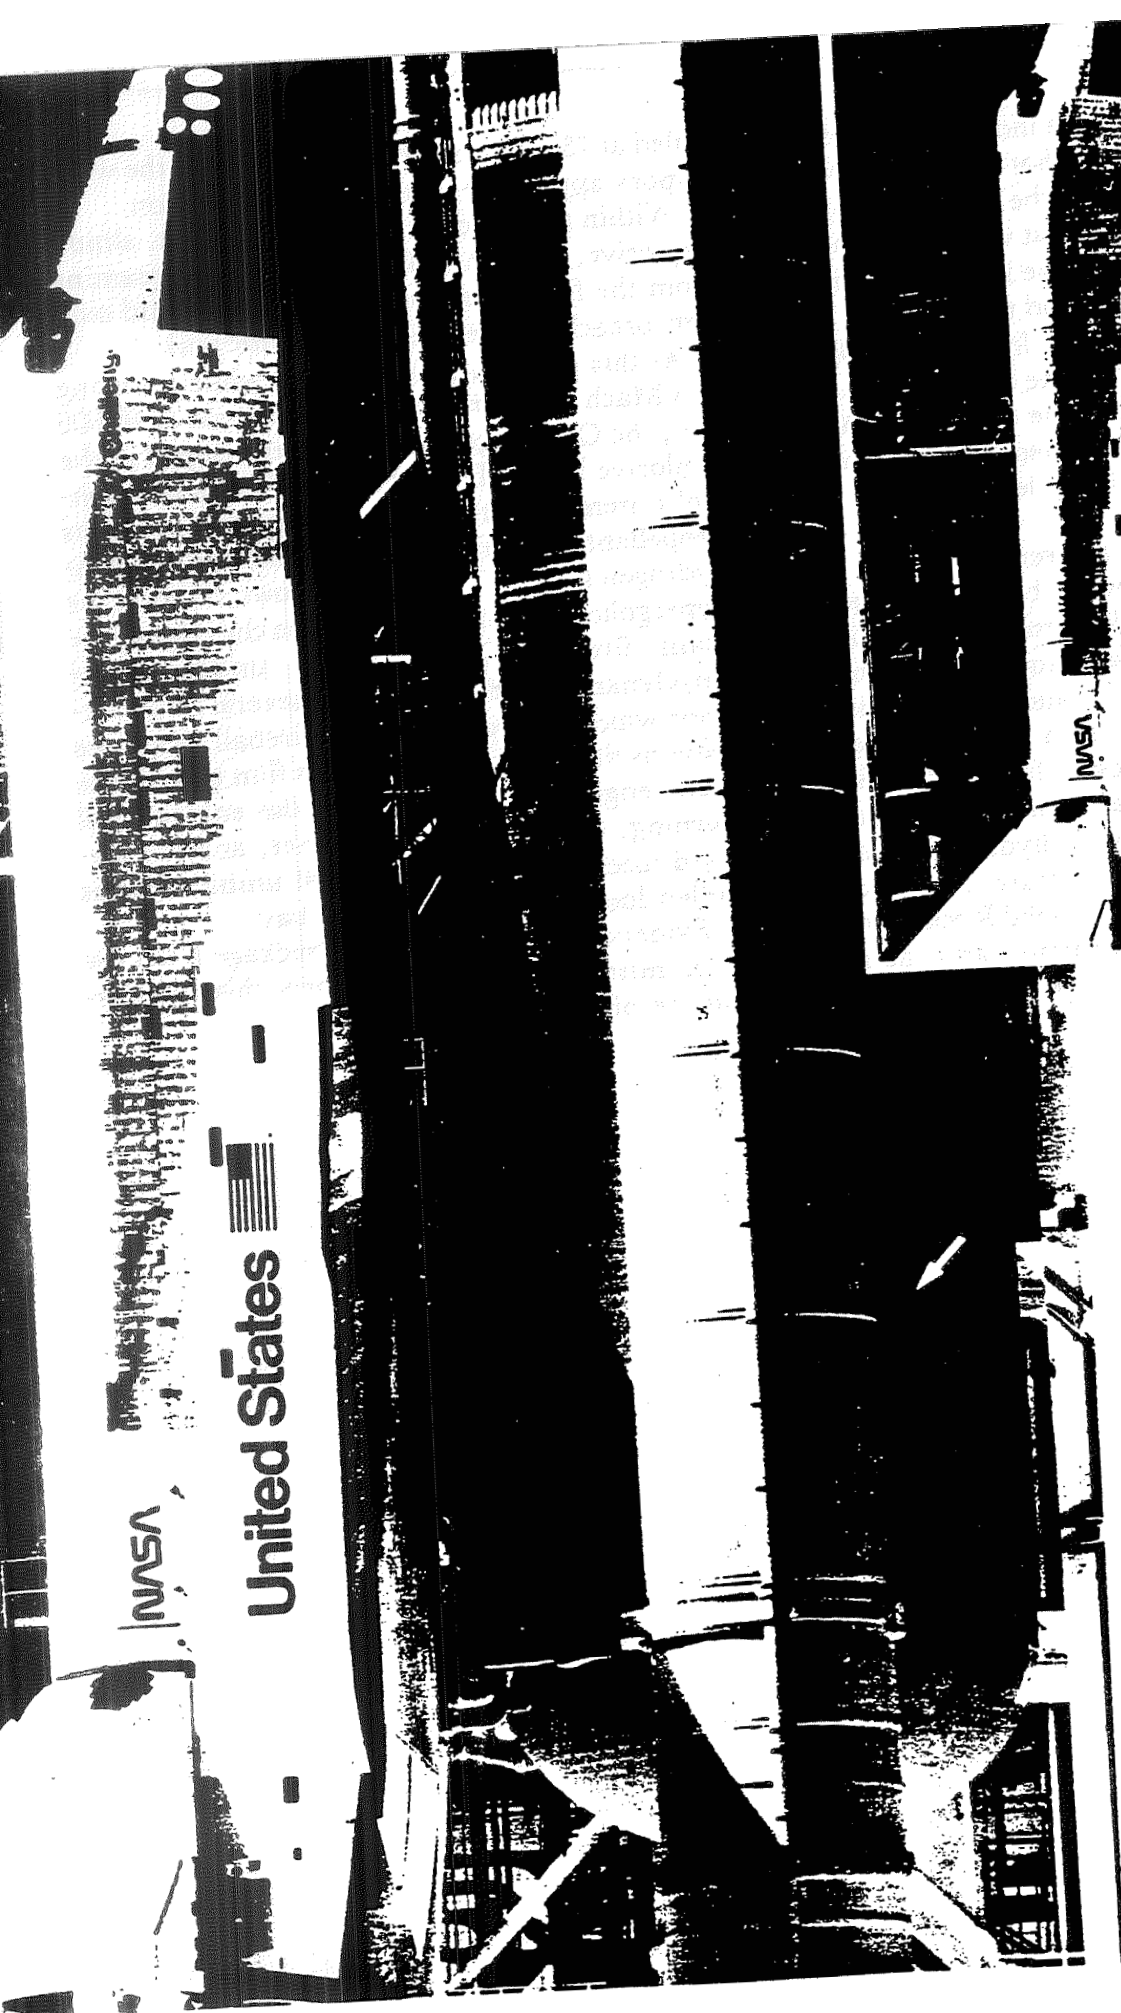
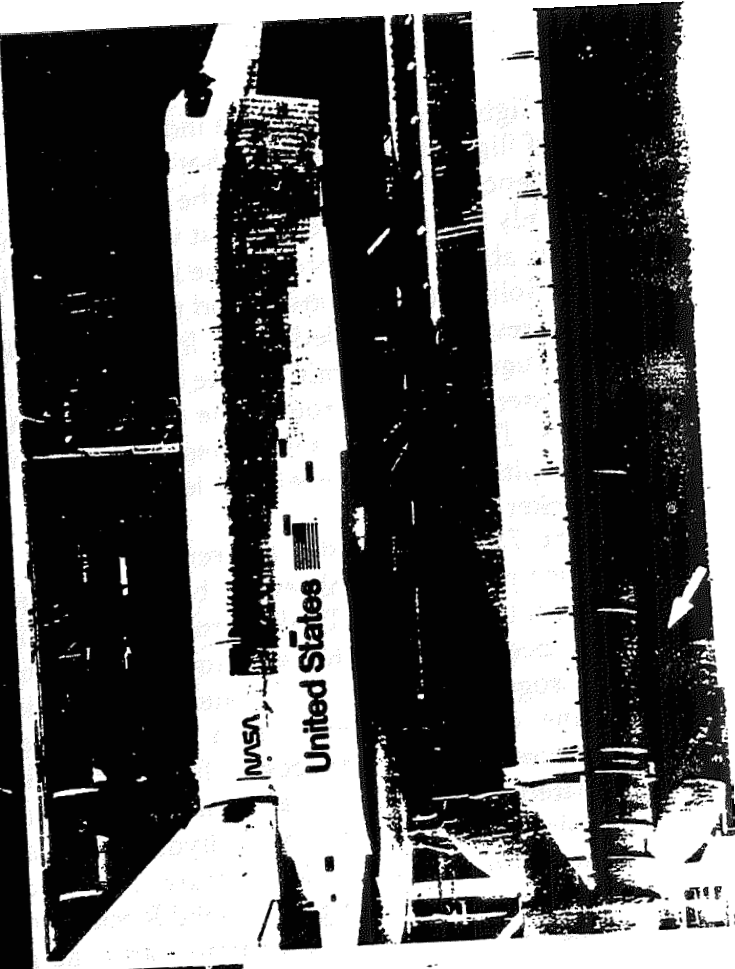
Immediately after solid rocket motor ignition, dark smoke (arrows) swirled out between the right hand booster and the External Tank. The smoke's origin, behavior and duration was approximated by visual analysis and computer enhancement of film from five camera locations. Consensus: smoke was first discernible at .678 seconds Mission Elapsed Time in the vicinity of the right booster's aft field joint.

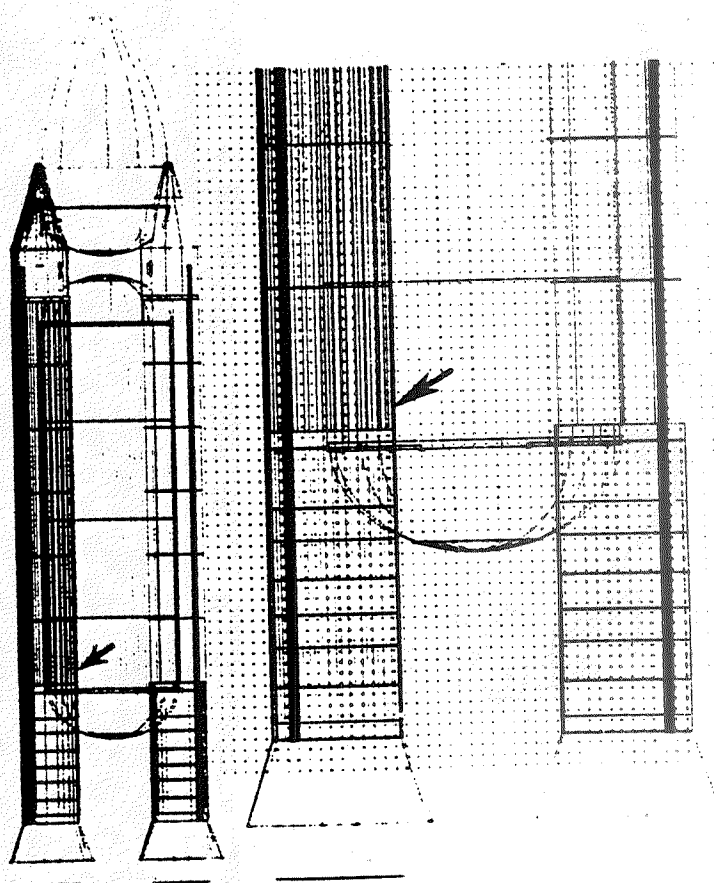
At 58.788 seconds, the first flicker of flame appeared. Barely visible above, it grew into a large plume and began to impinge on the External Tank at about 60 seconds. Flame is pinpointed in the computer drawing between the right booster and the tank, as in the case of earlier smoke puffs. At far right (arrow), vapor is seen escaping from the apparently breached External Tank.

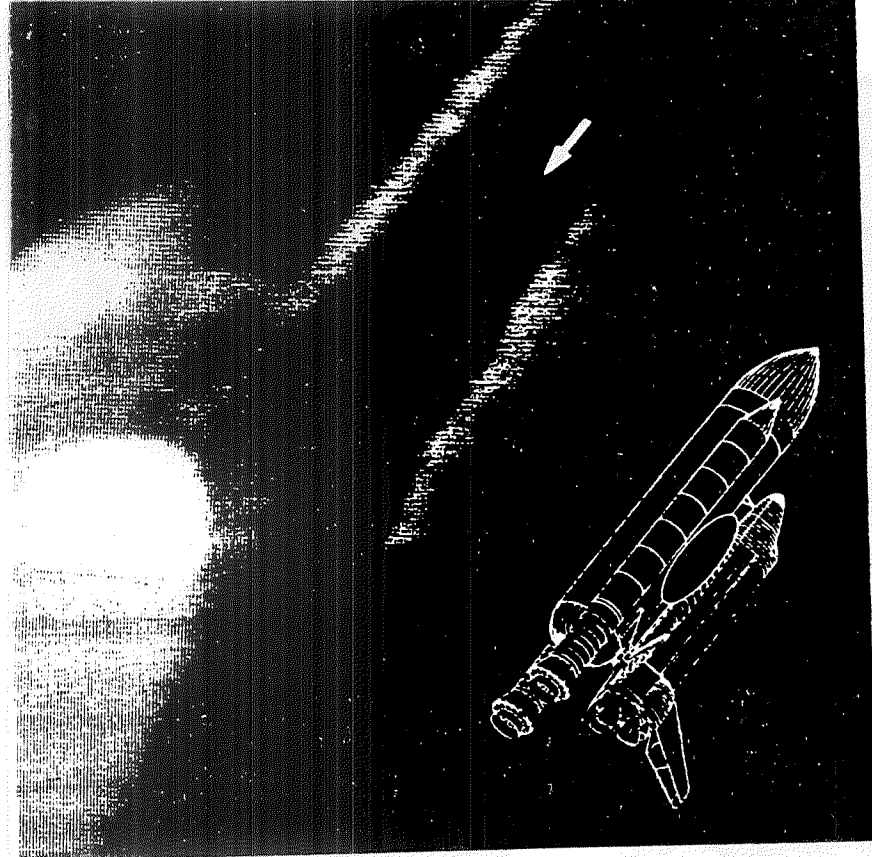
Camera views indicate the beginning of rupture of the liquid hydrogen and liquid oxygen tanks within the External Tank. A small flash (arrows above) intensified rapidly, then diminished. A second flash,

attributed to rupture of the liquid oxygen tank, occurred above the booster/tank forward attachment (below left) and grew in milliseconds to the maximum size indicated in the computer drawing.

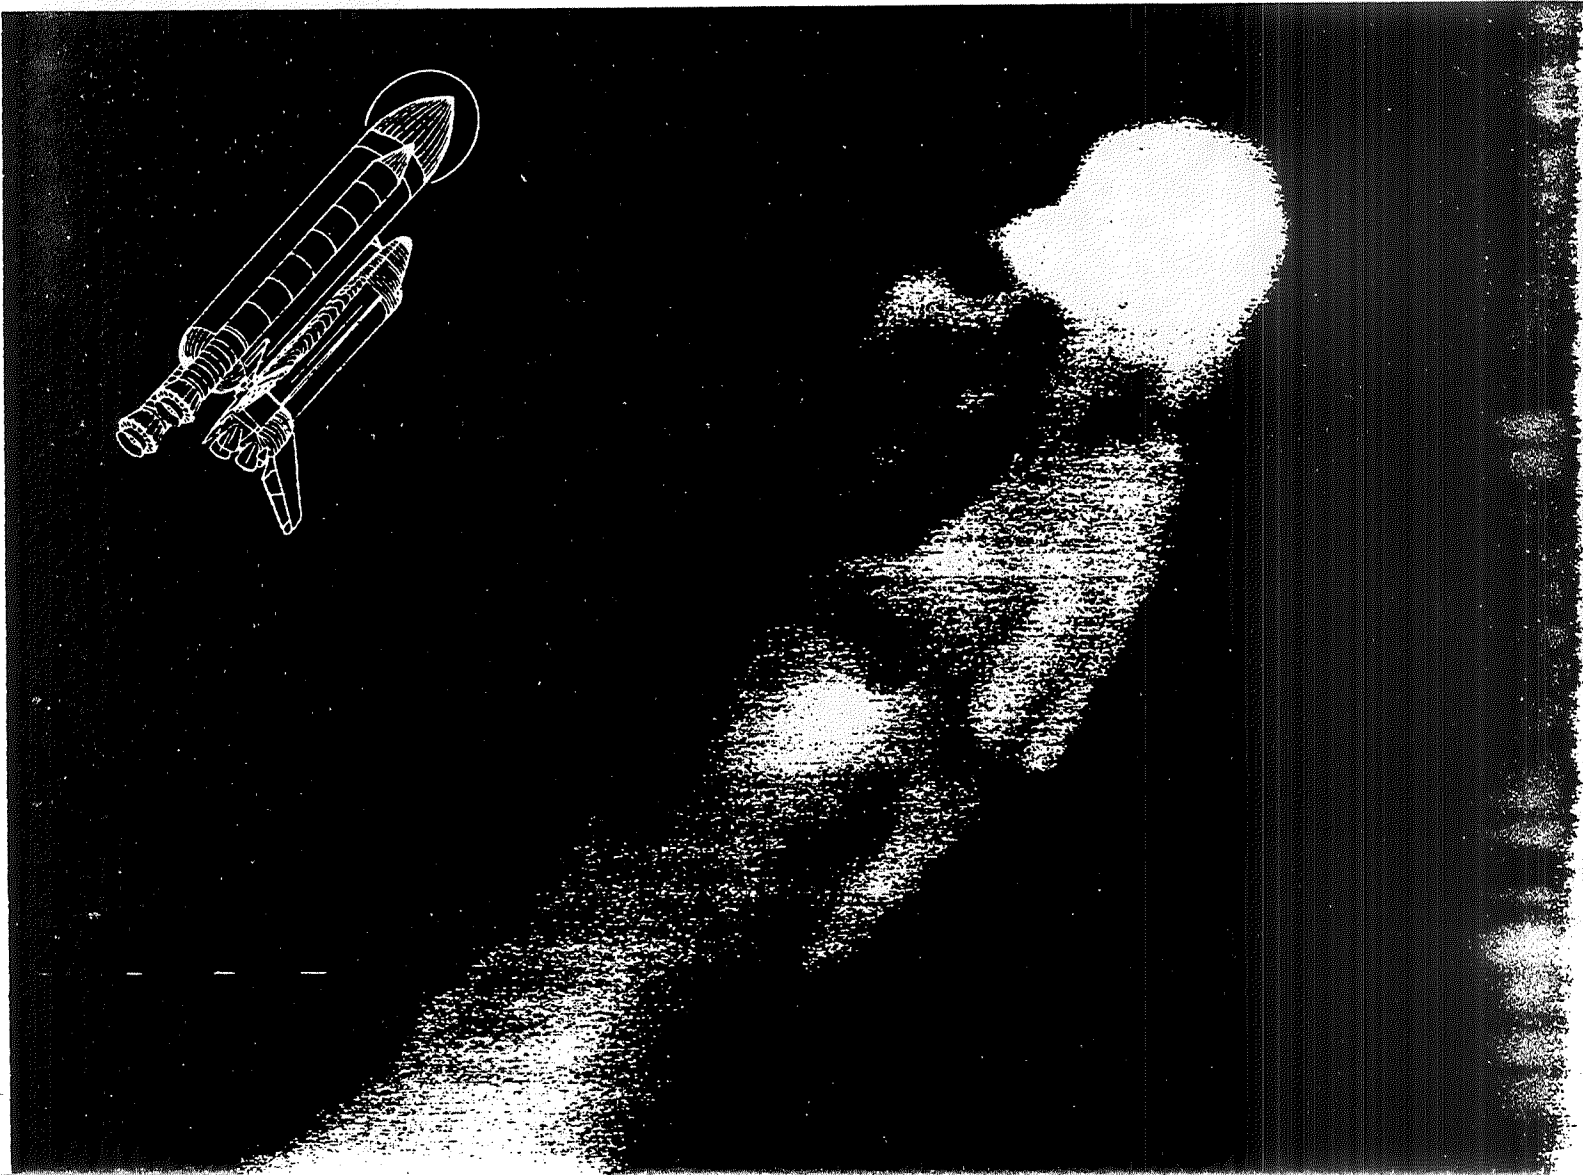
Structural breakup of the vehicle began at approximately 73 seconds. Fire spread very rapidly. Above, a bright flash (arrow) is evident near the nose of the Orbiter, suggesting spillage and ignition of the spacecraft's reaction control system propellants. At left, the two Solid Rocket Boosters thrust away from the fire, crisscrossing to form a "V." The right booster—identifiable by its failure plume—now to the left of its counterpart. At right, the boosters diverge farther; the External Tank wreckage is obscured by smoke and vapor. The Orbiter engines still firing, is visible at bottom center.

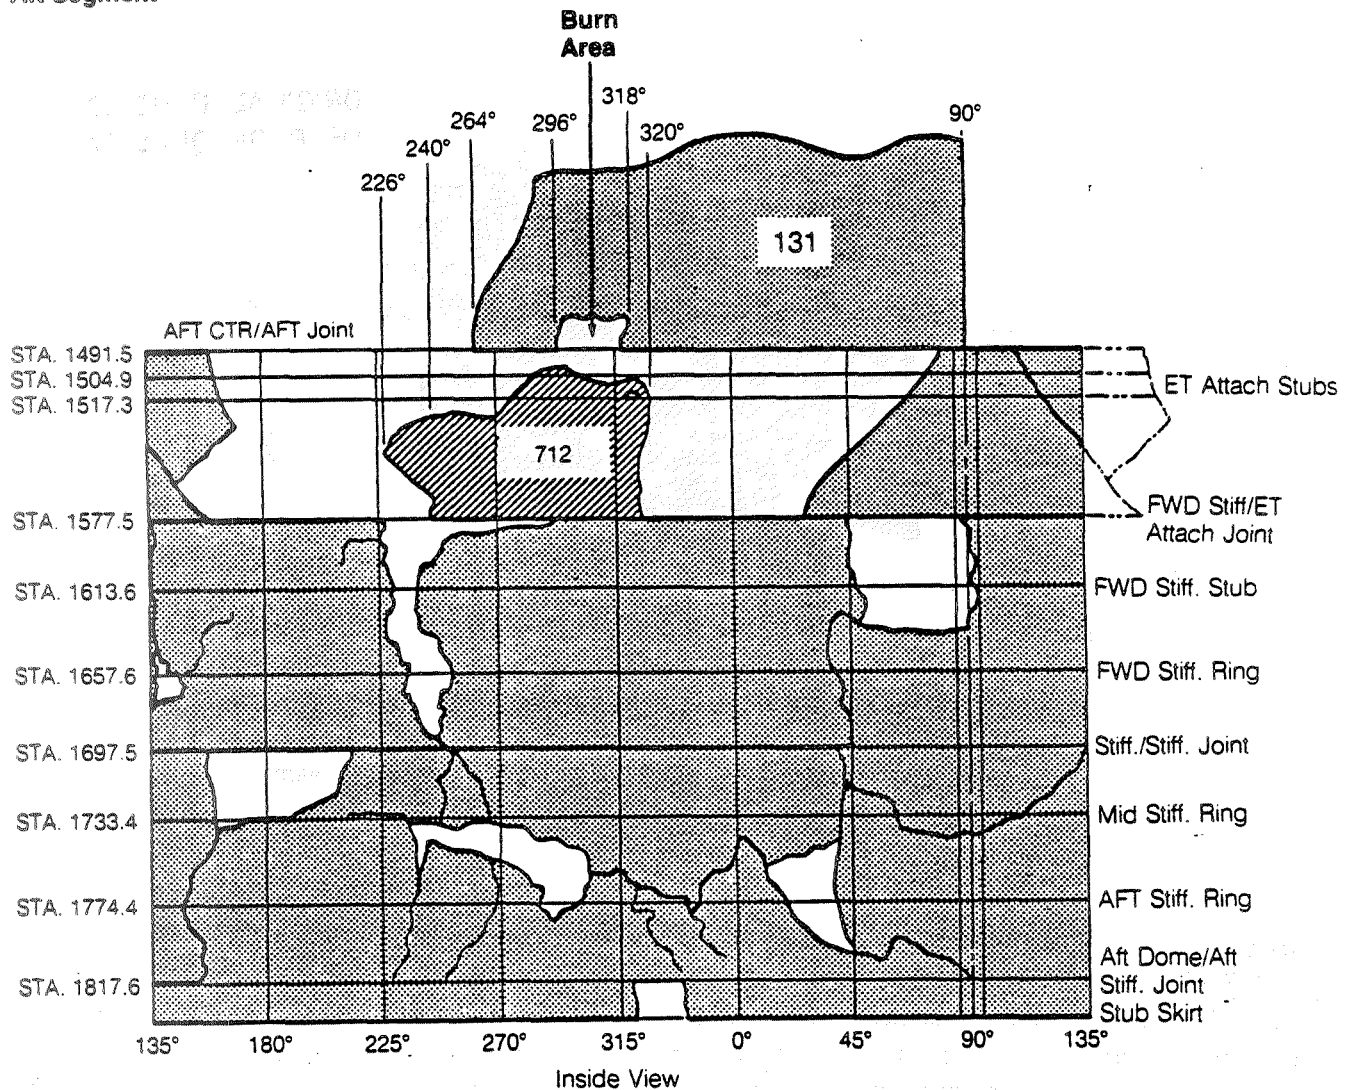
Figure 25  
Drawing depicts pieces of right Solid Rocket Booster aft segment recovered. At top is piece of aft center segment.

Some observations were made from a detailed examination of the aft center section of the joint, contact 131. This piece (photo I) shows a large hole that is approximately centered on the

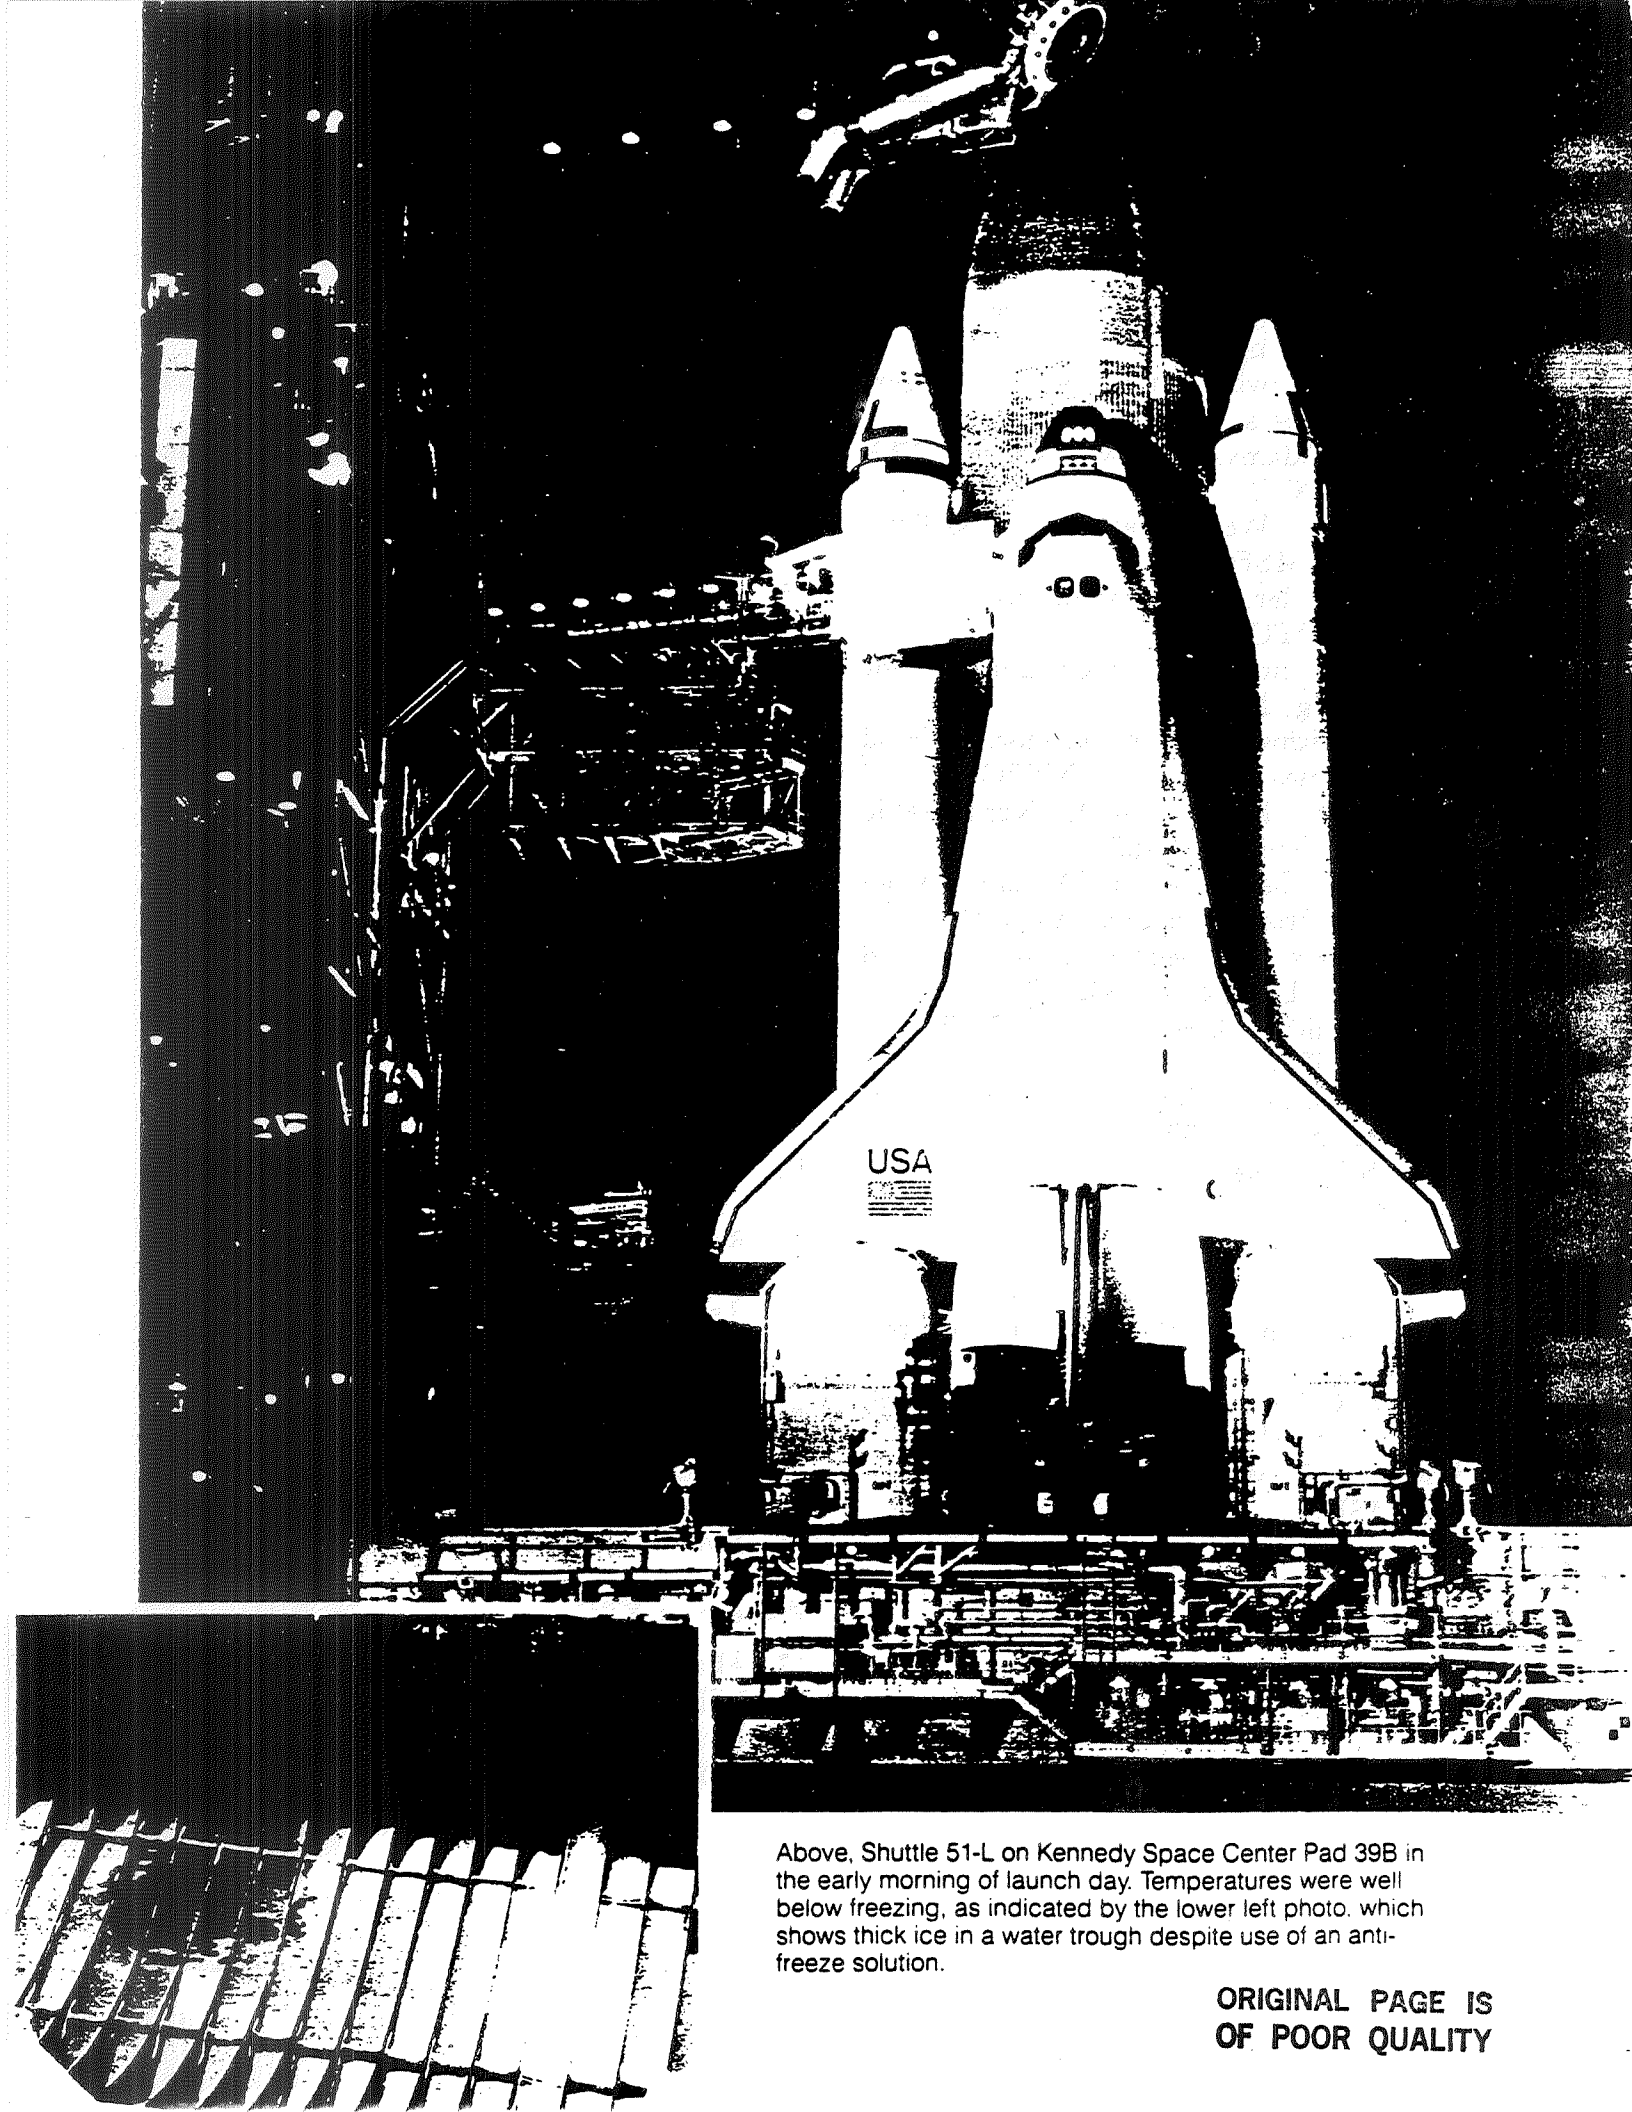
Above, Shuttle 51-L on Kennedy Space Center Pad 39B in the early morning of launch day. Temperatures were well below freezing, as indicated by the lower left photo, which shows thick ice in a water trough despite use of an anti-freeze solution.

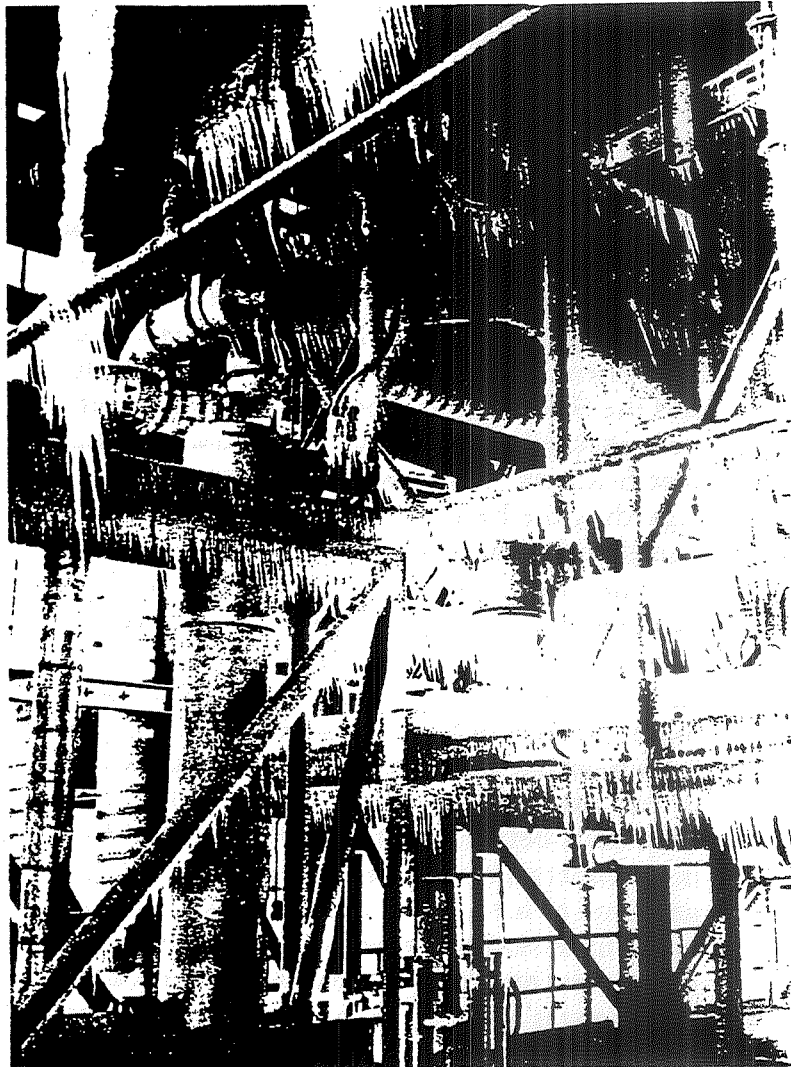
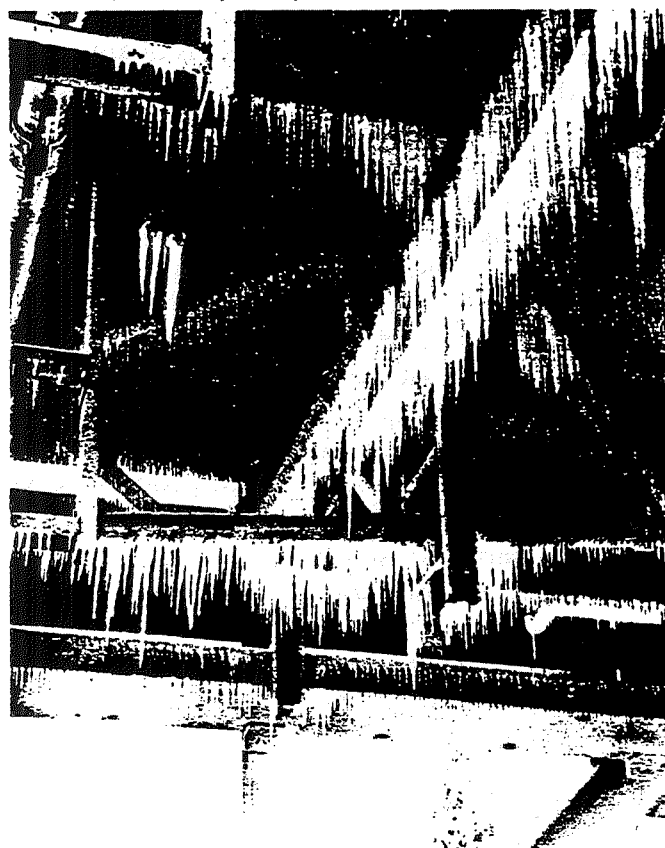
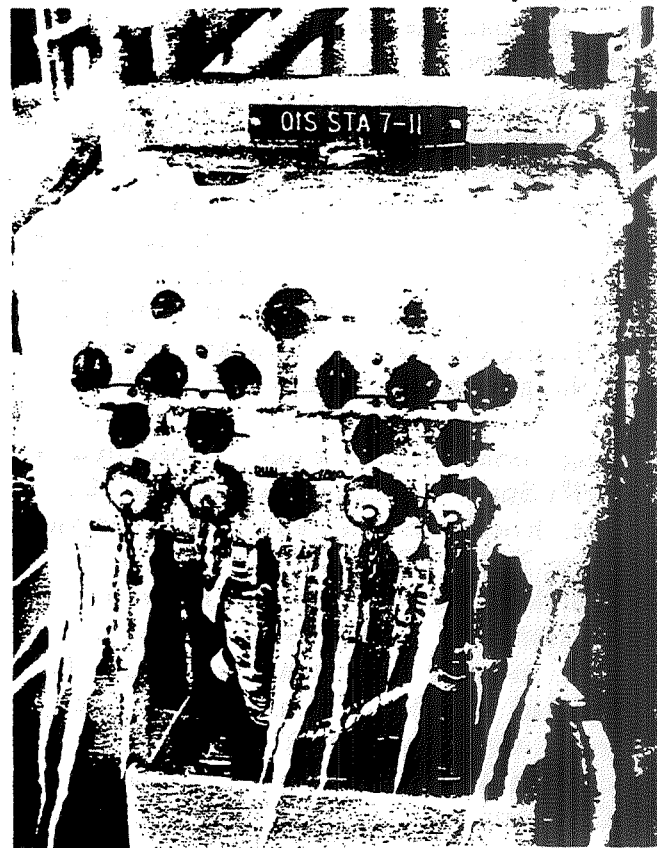
Above, foot long icicles on a lower level of the Fixed Service Structure frame the attachment point where the Orbiter is attached to the external tank (arrow). Icing was even more extensive at upper levels of the service structure (upper right and below). At right below is a ground communications box (not used during launch) rendered inoperable by heavy ice.
